Research Report
KTC-05-01/SPR 270-03-1I

SWELLING PAVEMENTS: KY 499 ESTILL COUNTY

Swelling Pavement: KY 499 Estill County

March 2005

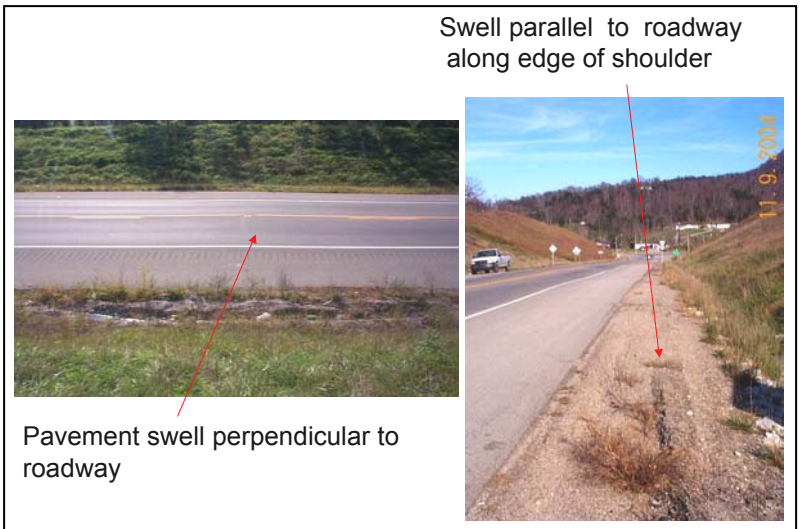
Figure 4. Photographs of Observed Swell

Field-testing was performed in cut sections where most of the swelling was observed during the initial field reconnaissance. The areas of pavement swelling were humps that measured a few inches in height. Generally, the humped areas occur perpendicular to the roadway alignment in cut sections. Swelling was also noticed in cut sections parallel to the roadway at the shoulder drainage ditch interface (right side photo in Figure 4).

Standing water was observed in drainage ditches on both sides of the road at the central test site. The ditch was not effective due to slumping of the cut slopes and swelling from the shoulders. Drainage was better at the other two sites (the two on each end). These drainage ditches were on steeper grades and constructed with channel lining.

After completion of field-testing by the University of Kentucky Transportation Center (UKTC) personnel in December of 2004, the pavement was milled in areas where swelling was observed to be the most severe.

Drainage ditches should be reconstructed at the central test site. The pavement humps will require periodic milling. Temporary patches will also have to be used. Periodic measurements of points placed on the pavement at different locations during this study may aid in establishing the pattern of swelling and provide some hint of the long-term swelling behavior of the compacted and intact Crab Orchard shale.
